Intel® Mobile Pentium® III Processor Specification Update

Release Date: September 2000

Order Number: 245306-011

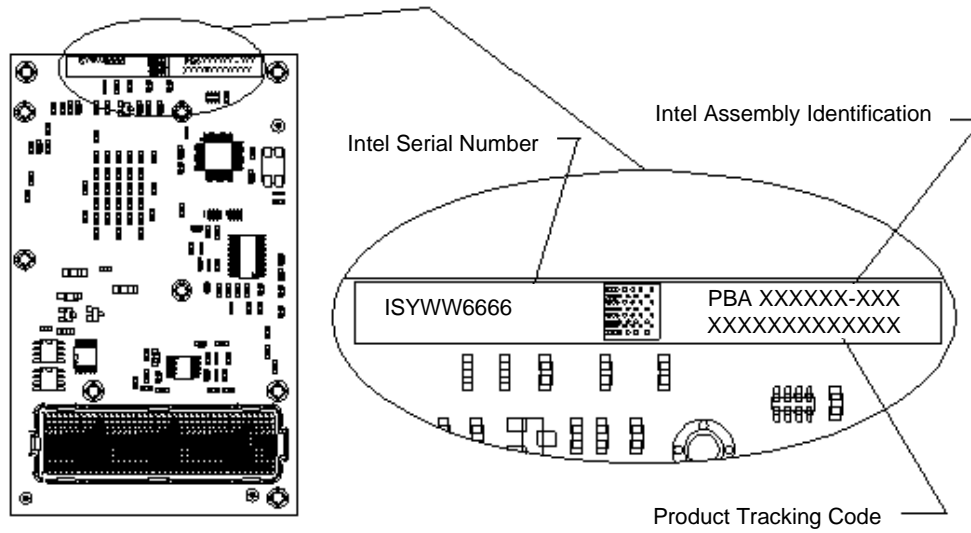
Intel® Pentium® III Processor Mobile Module Markings

The Product Tracking Code (PTC) shows the assembly level of the module. The PTC is on the secondary side of the module and contains 13 characters. See the example below:

Note: For other Intel Mobile Modules, the second field (B) is defined as:

Pentium® II Processor Mobile Module (MMC-1) = D
 Pentium® II Processor Mobile Module (MMC-2) = E
 Pentium® II Processor Mobile Module With On-die Cache (MMC-1) = F
 Pentium® II Processor Mobile Module With On-die Cache (MMC-2) = G
 Celeron™ Processor Mobile Module (MMC-1) = H
 Celeron™ Processor Mobile Module (MMC-2) = I
 Celeron™ Processor (.18μ) Mobile Module (MMC-2) = N

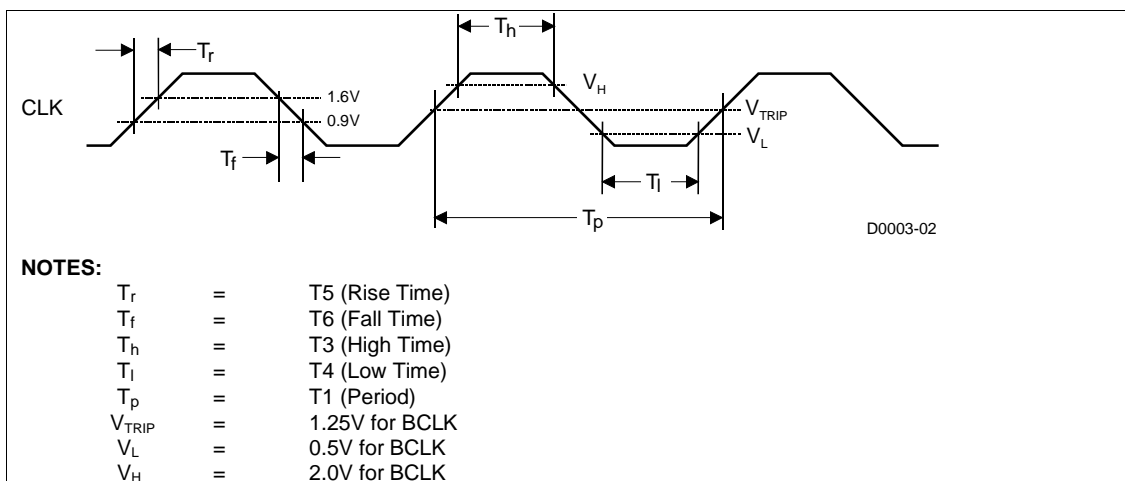
Figure 7. BCLK Timing Waveform

Symbol	Parameter	Min	Typ	Max	Unit	Figure	Notes
	System Bus Frequency		100		MHz		
T1	BCLK Period		10		ns	Figure 7	Note 2
T2	BCLK Period Stability			± 250	ps		Notes 3, 4
T3	BCLK High Time	2.70			ns	Figure 7	at >2.0V
T4	BCLK Low Time	2.45			ns	Figure 7	at <0.5V
T5	BCLK Rise Time	0.175		0.875	ns	Figure 7	(0.9V – 1.6V)
T6	BCLK Fall Time	0.175		0.875	ns	Figure 7	(1.6V – 0.9V)

1. All AC timings for GTL+ and CMOS signals are referenced to the BCLK rising edge at 1.25V. All CMOS signals are referenced at 0.75V.
2. The BCLK period allows a +0.5 ns tolerance for clock driver variation.
3. Not 100% tested. Specified by design/characterization.
4. Measured on the rising edge of adjacent BCLKs at 1.25V. The jitter present must be accounted for as a component of BCLK skew between devices.

For B0 step processors, the $V_{IH,BCLK}$ Min spec is changed to 2.0V (from 1.7V for A2 step) and $V_{IL,BCLK}$ Max spec is changed to 0.5V (from 0.7V for A2 step). Due to this, new values are specified for BCLK high and low times for B0 step processors. These modifications affect corresponding specs in Table 13, Table 14, Table 24, and Figure 7 in *Mobile Pentium® III Processor in BGA2 and Micro-PGA2 Packages datasheet* (Order Number 245302-002).
